# Safety Alert

## Gritter Fire

## Milton Keynes - Gritter Fire

Ref 081b

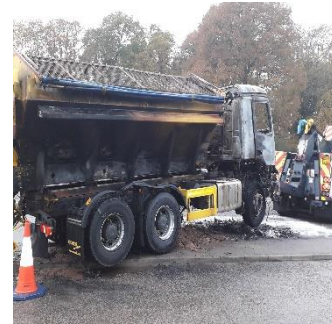
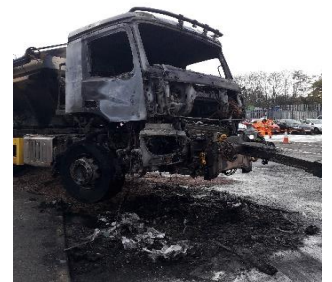
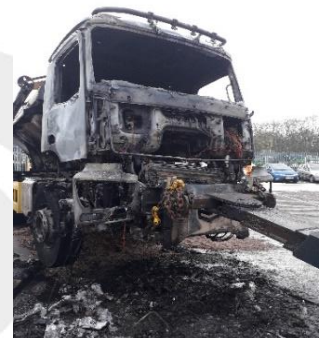
An incident has occurred involving a winter maintenance vehicle catching fire upon return to the depot at Milton Keynes after completing a grit run. The vehicle involved was a six-wheeler Econ gritter with a Mercedes chassis.

On return to the depot after driving through the depot barrier, the driver noticed flames coming around the body of the gritter on the passenger side. The driver continued to drive the gritter forward away from the building and parked the vehicle approximately 30m away. Immediately after parking up the driver exited the vehicle, jumping from the cab. From the point of exiting the cab it was clear the vehicle body and cab had caught fire. A member of the workforce ran over to assist the driver while another called the fire services who attended site and controlled the fire within about 15mins.

- All cabs are clear with no obstruction and access steps are clean
- Vehicles are clean with no remanence of diesel/ oil on the body
- Daily vehicle checks abeing undertaken
- 5 minutes on safety undertaken for all operations at the start of their next shift with a reminder on 'Fire & Rescue' not to put themselves in any danger
- Skyguard devices to be worn and switched on during all lone working activities

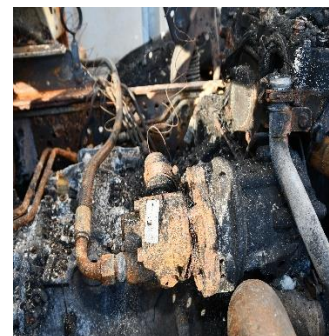
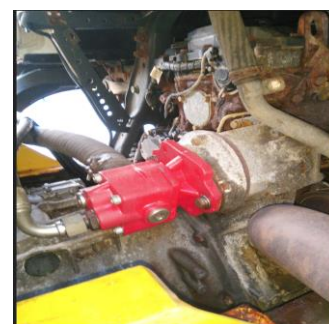
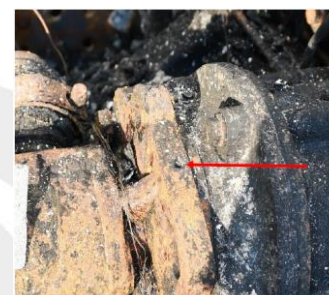
Examination suggests that a potential cause could have been as a result of pressurised hydraulic oil being discharged over the exhaust manifold and turbo charger which subsequently caused the fluid to ignite. The oil is believed to have come from the permanently driven hydraulic pump mounted on the rear of the engine close to the exhaust manifold. As shown in picture 2. Whilst the root cause remains inconclusive at present we ask that the following actions are taken:

- **Examine all similar vehicles for any evidence of oil leaks from the pump or pipework/unions/connections.**
- **Undertake the examination with the gritter engine running and the gritting hydraulic control in the on position and off position as the pump runs continually (to confirm any leak in either mode).**
- **Check the valve block for any oil loss, and any oil loss to the area generally.**
- **Particular attention should be given to the centre of the pump flange (between the two unused fixing holes) which can be seen as unpainted on the replacement pump as this is understood to be the point at which oil leaked.**
- **Report and investigate the requirement to add hydraulic oil to the reservoir at any time.**
