# Safety Alert

## People Plant Interface

8 January 2020

**Huyton Asphalt**

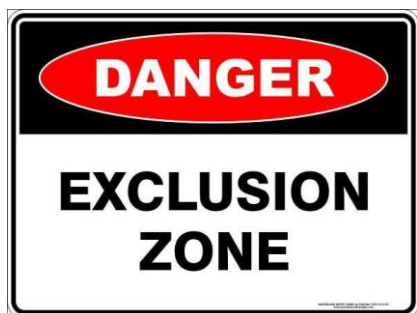
**DO YOU KNOW  
YOUR SAFE ZONES?**

- A full investigation review was carried out at Director Level.
- A site wide safety stand down was undertaken to raise awareness and H&S behaviours.
- Induction & Permit reviewed to identify the method of communication and segregation during similar operations.
- Review Risk/No Risk zones and maintaining an exclusion area 75m +/- (25m) as per LANTRA guidance.
- Safe methodology to ensure no personnel works between the IPV and rear of any other vehicle (where possible).
- Traffic Management plans to identify high-risk areas and segregation distances as per LANTRA guidance.
- **If unsure STOP works immediately and ask.**
